Manhole Inspection Summary

Manhole # S35KK_005MH

Insp Date: **3/12/07 10:37 AM**

Location Address: **127 TRENTON ST**

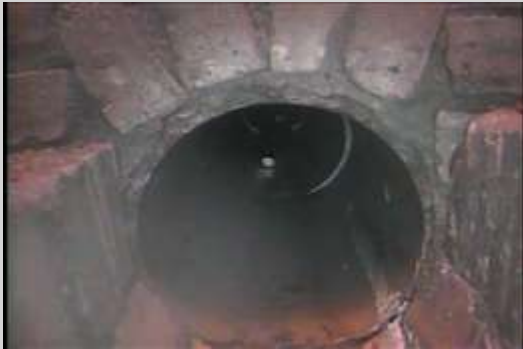
8 in. Circular Gravity Sewer Pipe Out @ 12 O'Clock

Invert Depth: **9.73** (ft.) Flow Characteristics: **Slow**

Infiltration: **None** Pipe Seal Cond: **Unknown**

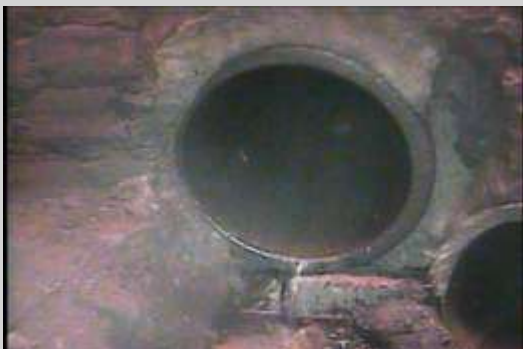
8 in. Circular Gravity Sewer Pipe In @ 8 O'Clock

Invert Depth: **9.28** (ft.) Flow Characteristics: **Slow**

Infiltration: **None** Pipe Seal Cond: **Unknown**
